DR. SPANG

Rectifying floodwater damage, Freiberger Mulde, Muldenbogen

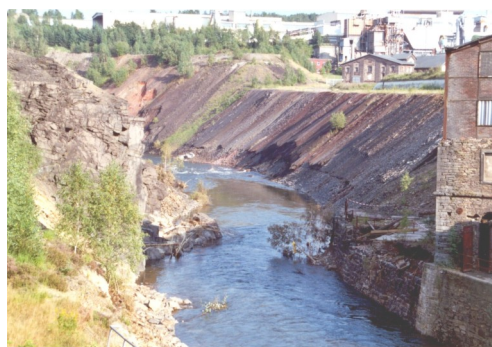
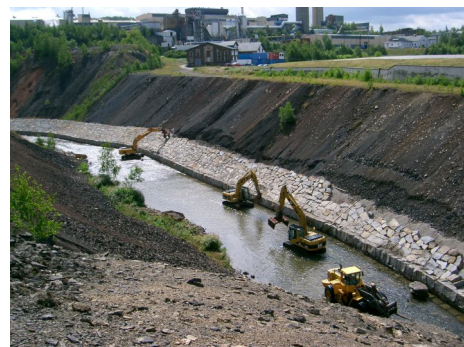
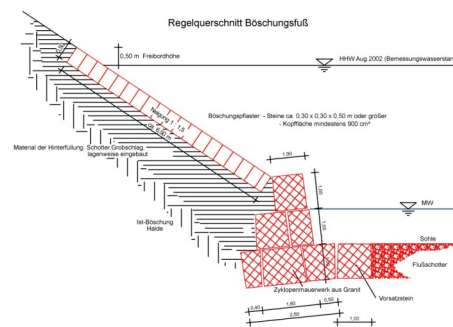
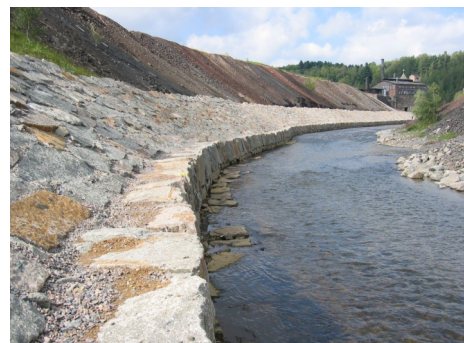
- Rectifying floodwater damage over a part section of the Freiberger Mulde, approx. 500 m long
- Repairs required to approx. 200 m of supporting wall, steep-sided slopes and river bed side beaching.
- Securing an area of damage on one bank wall (natural stone dry masonry)
- Securing the foot of the side slope over a run of approx. 30 m.

- Planning pursuant to HOAI, § 55, Lph 1 to 9, investigation of subsoil and assessments of masonry work
- Determining the conditions of the subsoil and foundations in the area at risk, geotechnical recording of the exposed rock slopes in the area under investigation; suggestion for repair, proof of safe status for the bank walls and the adjoining slope, execution planning and monitoring of construction.
